# NOTICE

Soils and Engineering Geology Study Proposed Canyon Cove Development 6500 South and Wasatch Boulevard Salt Lake City, Utah For Envirowest

Supplemental Discussions
Active Faults
Proposed Canyon Cove Development
6500 South and Wasatch Blvd.
Salt Lake City, Utah
For Envirowest

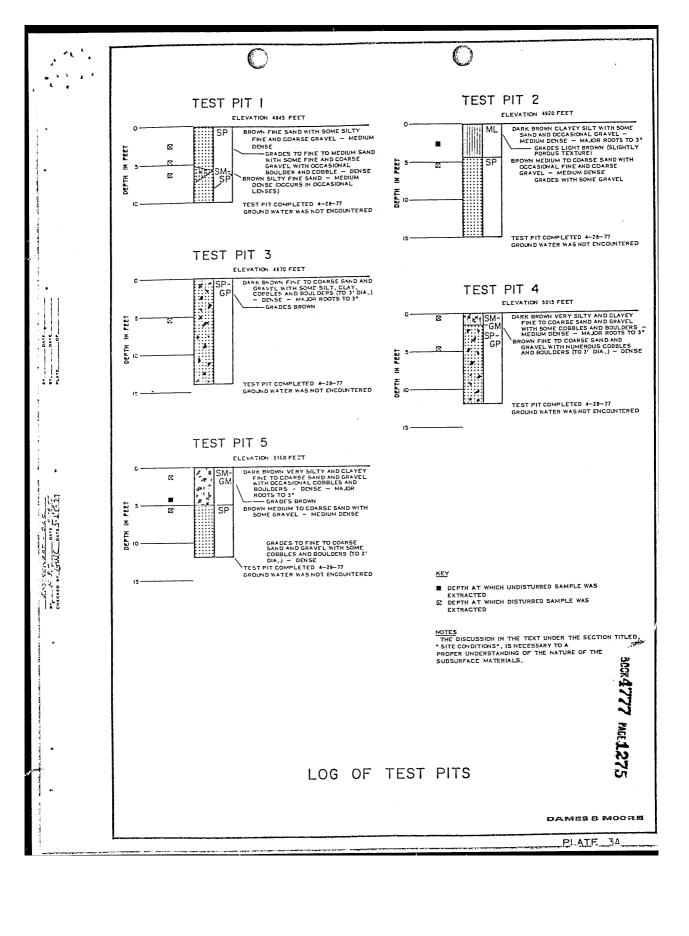
- Plot Plan Plate 2

Surface features are shown on Plate 2, Plot Plan.

The site is underlain principally by granular materials deposited within ancient Lake Bonneville in the southern two-thirds of the property and by granular alluvial fan deposits in the northern third of the property. The steep slopes along the east property boundary are underlain by shale and quartzite bedrock and a thin soil developed from the parent rock. Detailed descriptions of the soils encountered in the test pits excavated at the site are presented on Plates 3A and 3B, Log of Test Pits. The soils are described in accordance with the nomenclature presented on Plate 4, Unified Soil Classification System. Locations of the test pits and site geologic features are shown on Plate 2.

Projected and defined fault locations are shown on Plates 1 and 2.

be held to a minimum. As a minimum, the design requirements for Seismic Zone 3 as outlined in the 1976 UBC should be followed. We also recommend that no structure for human occupancy be constructed within 50 feet of an active fault. The approximate locations of the inferred active faults which pass through the site are shown on Plate 2.
