# WATTS REMUND FARMS SUBDIVISION DEVELOPMENT AGREEMENT (PHASE I)

THIS DEVELOPMENT AGREEMENT for Phase I of the Remund Farms Subdivision (the "Agreement") is entered into as of this 2 day of August , 2018, by and between MIDWAY SPRINGS, LLC (hereinafter called the "Developer") and the CITY OF MIDWAY, UTAH, a political subdivision of the State of Utah (hereinafter called the "City"). Developer and the City are, from time to time, hereinafter referred to individually as a "Party" and collectively as the "Parties." Unless otherwise noted herein, this Agreement supersedes and replaces any previous development agreements entered into by and between the Developer and the City involving the same Property (defined below) and is the entire, complete Agreement between the Parties.

- C. The Developer intends to develop the Property as a subdivision consisting of 96 building pads and one single family residential lot, and related appurtenances and improvements. This Project is commonly known as Phase I of the Remund Farm Subdivision. The subdivision is approximately 11.2 acres and is located in the R-1-15 zone.

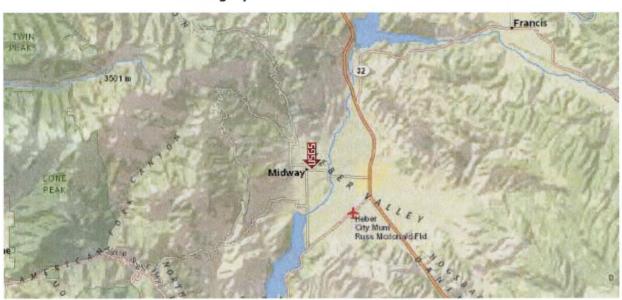
Site Soil Classification Site Class D - "Stiff Soil"

$$S_s = 0.633 g$$

$$S_{D1} = 0.278 g$$
